OKLAHOMA
GEOLOGICAL
SURVEY

CIRCULAR 88

Stability Problems Associated with Abandoned Underground Mines in the Picher Field Northeastern Oklahoma

1986

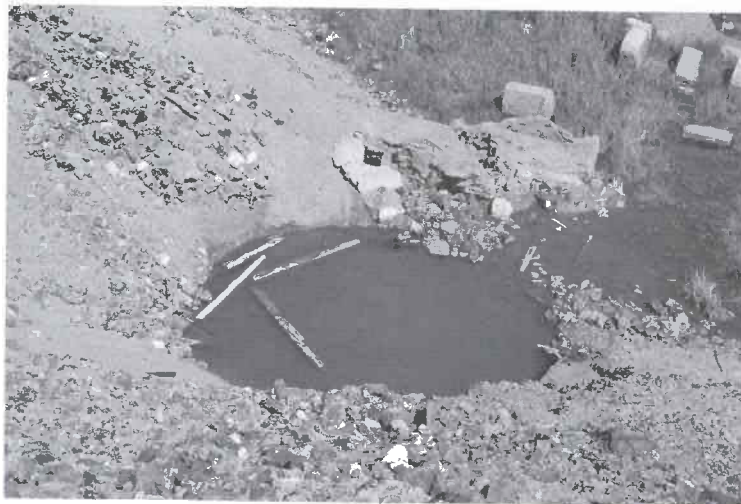
Title Page Illustration

A 20-ft-diameter circular collapse, Howe Mine, 29N-23E-17.

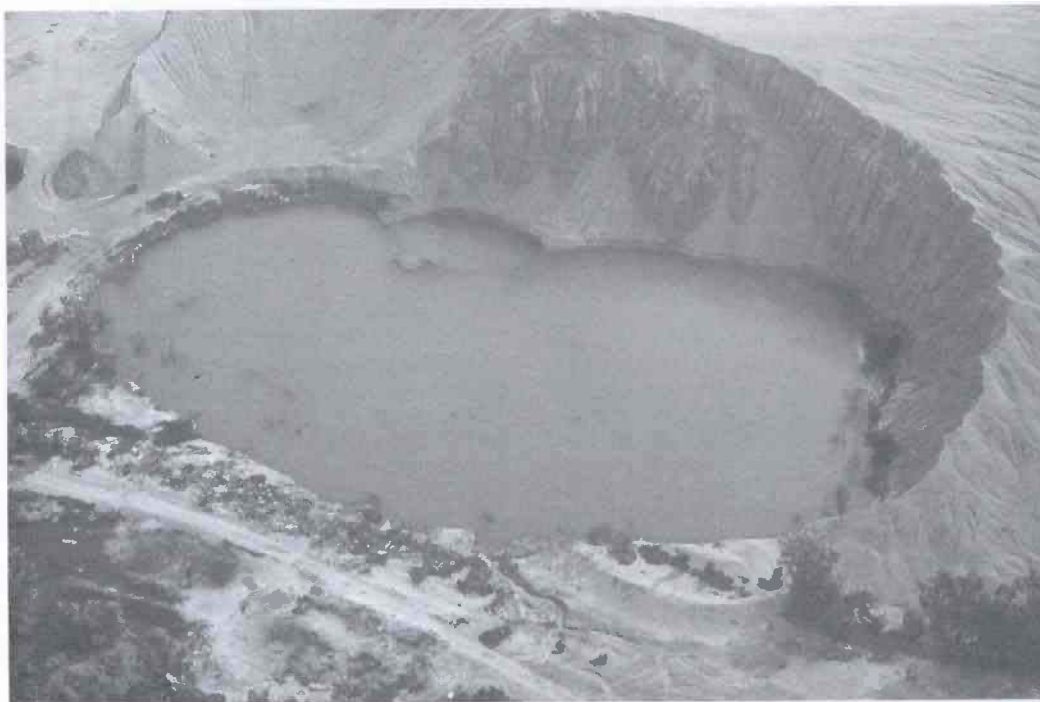
Most major collapses have occurred in rural areas. The largest concentration of shaft-related major collapses is found in a zone 0.5 mi wide by 1 mi long, extending southward from Hockerville (E½ secs. 14 and 23, T29N, R23E); 10 shafts are involved in eight separate collapses. Other areas that include several major shaft-related collapses are in sec. 19, T29N, R23E, west of Cardin, and near Commerce. The largest collapse feature in the district is associated with three shafts at the Domado Mine, sec. 29, T29N, R23E (Fig. 6). This collapse is 560 ft long and 400 ft wide, covering 4.04 acres, and is filled with water.

Figure 6. Aerial view of 4.04-acre collapse associated with three shafts at Domado Mine, 29N-23E-29 (1-3).

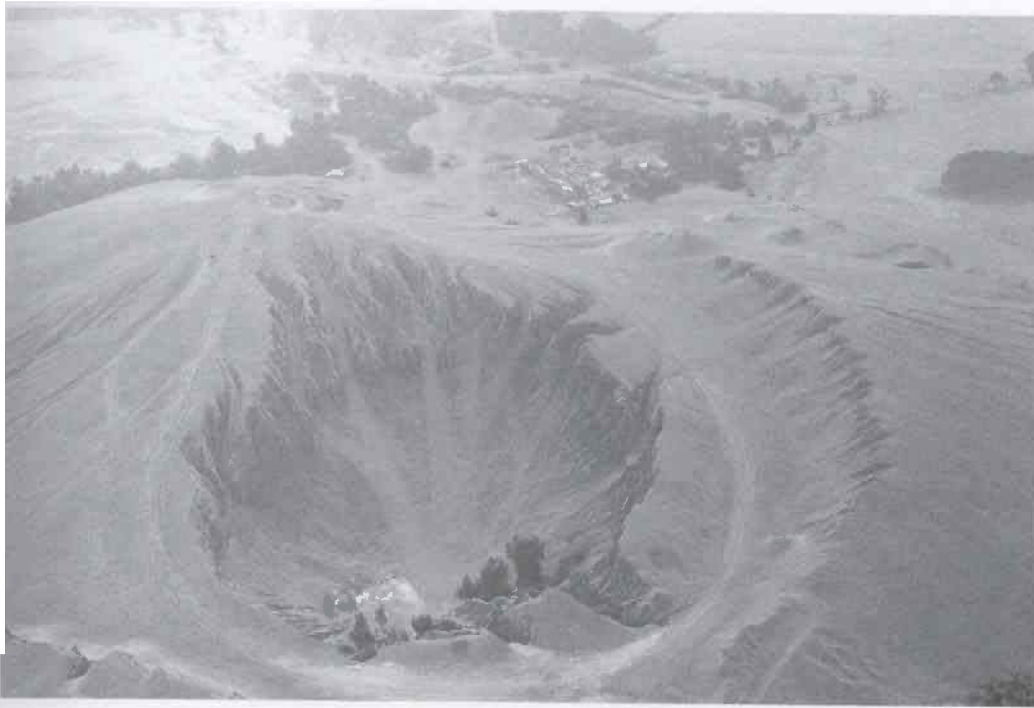
Of the 55 non-shaft-related collapses which were located, 30 fall within the major-collapse category. Approximately 20 surface acres have been disturbed as a result of non-shaft-related collapses. Sec. 1, T28N, R22E, west of Commerce, and sec. 19, T29N, R23E, west of Cardin, contain the largest concentration of non-shaft-related collapses. The largest non-shaft collapse is a 450- × 200-ft elliptical collapse that covers about 2.60 acres. This collapse occurs as a 20-ft-deep depres-

sion in a former tailings pile in sec. 30, T29N, R23E (Fig. 7).

Figure 7. Aerial view of largest non-shaft collapse (2.60 acres), Blue Goose No. 1 Mine, 29N-23E-30(1511).

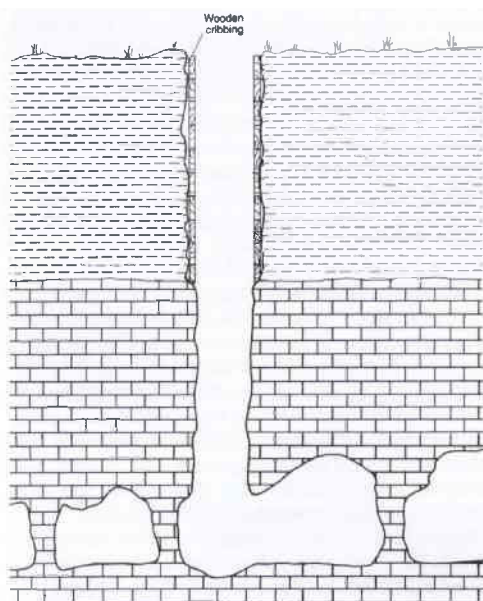
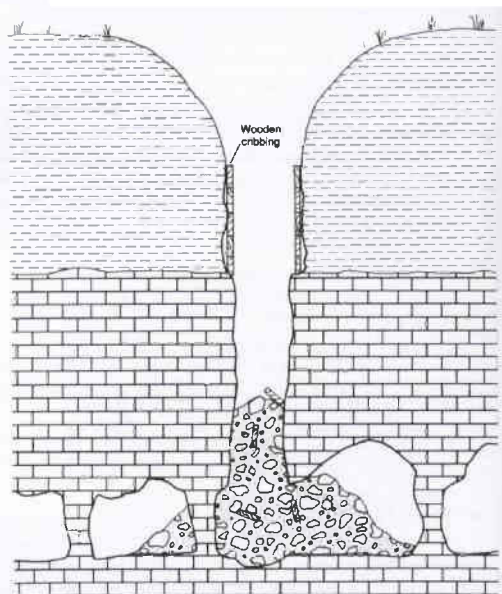
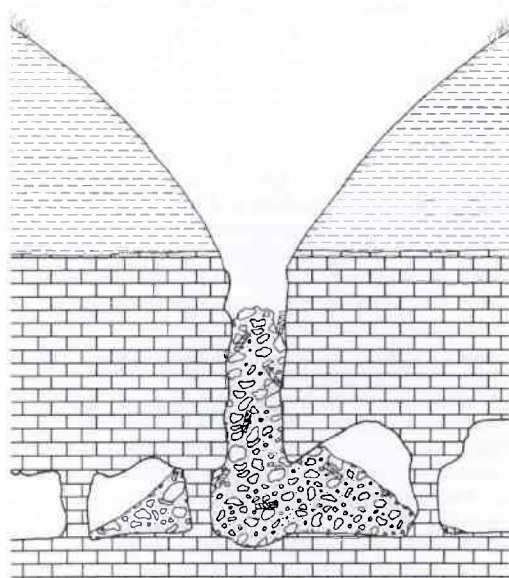
Most surface-collapse sites in the Oklahoma portion of the Picher Field are associated with abandoned mine shafts. Many shaft collapses begin with the deterioration of the wooden cribbing near the shaft collar (Fig. 10). Generally, a 40- to 60-ft-thick sequence of interbedded shale and sandstone occurs near the surface. This material is highly susceptible to erosion and will cave in toward the shaft. Many of the cave-ins are 20–60 ft in diameter (Fig. 11). Cave-ins that extend into the underground workings are generally accompanied by spectacular surface collapses 200–400 ft in diameter (Figs. 12,13). There are 481 shafts either open or in some stage of collapse. Probably 316 of these shafts could be closed or sealed.

Figure 10. Sequence of schematic cross sections illustrating various stages of surface collapse associated with shaft failure. A, typical open shaft and underground mine workings. B, early stage of shaft failure. C, advanced stage of shaft failure.

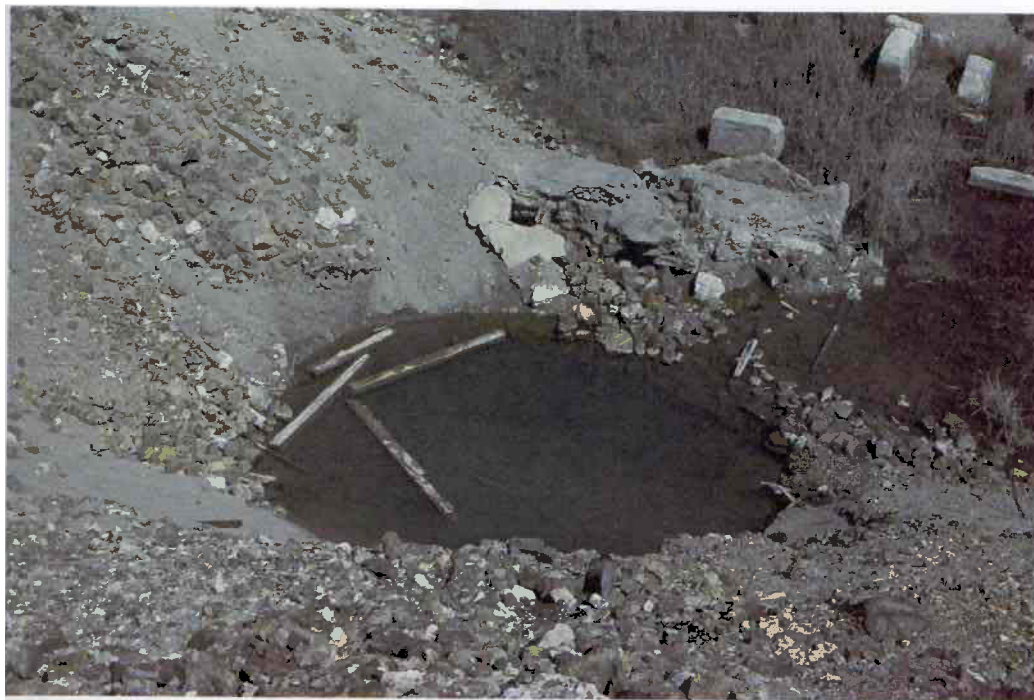
Most (66%) of the collapses, listed in Table 3 (Appendix) occurred prior to 1952. A summary of collapses for each time interval is listed in Table 6. Only one new collapse site was found after 1979: late in January 1984, a 20-ft-diameter collapse occurred near Commerce, in the southeast corner of sec. 1, T28N, R22E; this collapse was filled in February 1984. Also, several existing collapses have enlarged since 1979.

Figure 11. A 20-ft-diameter circular collapse, Howe Mine, 29N-23E-17(41).

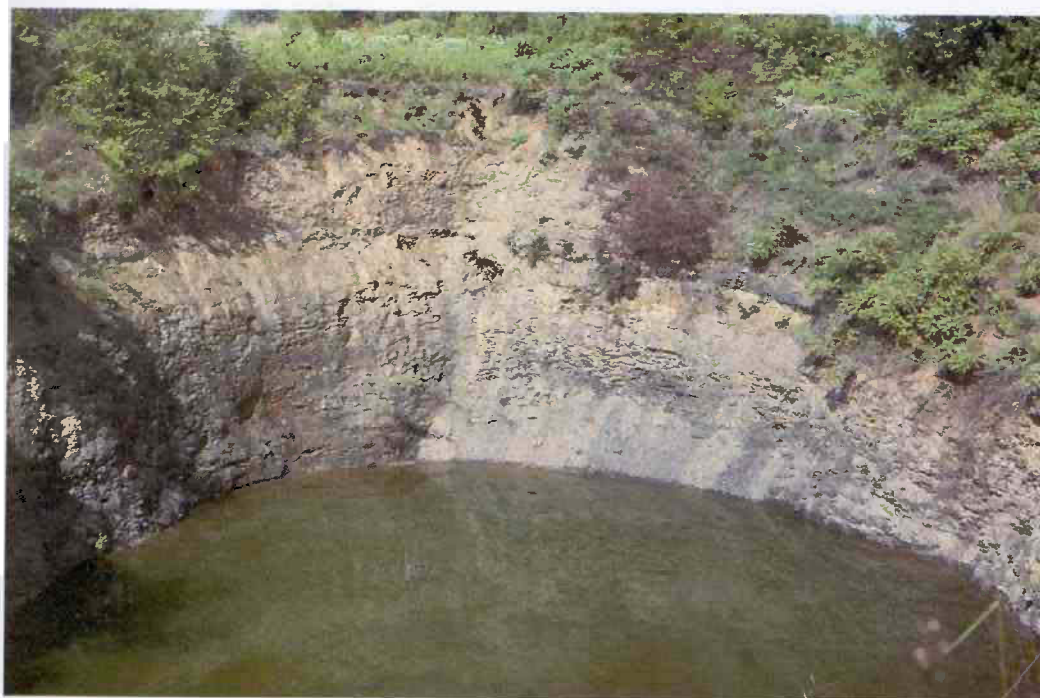
Figure 12. A 180- x 100-ft elliptical collapse, Gordon No. 2 Mine, 29-23E-18(8). Water level is approximately 35 ft below surface.

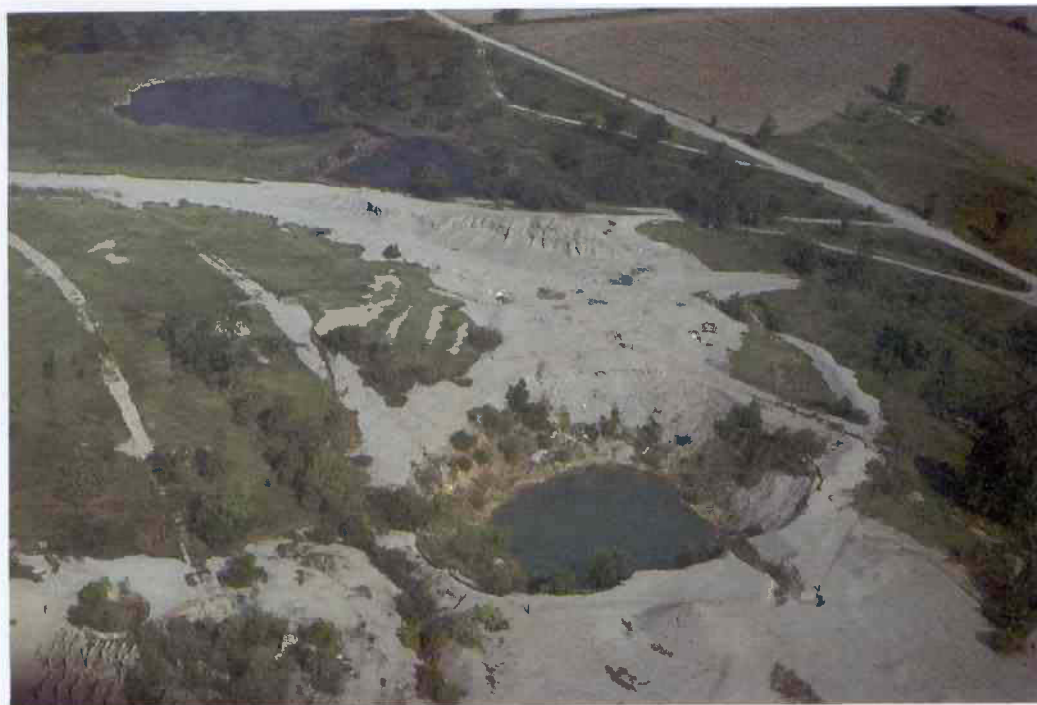
Figure 13. Two major shaft-related collapses, Anna Beaver lease, 29N-23E-19 (6, upper; 7, lower).

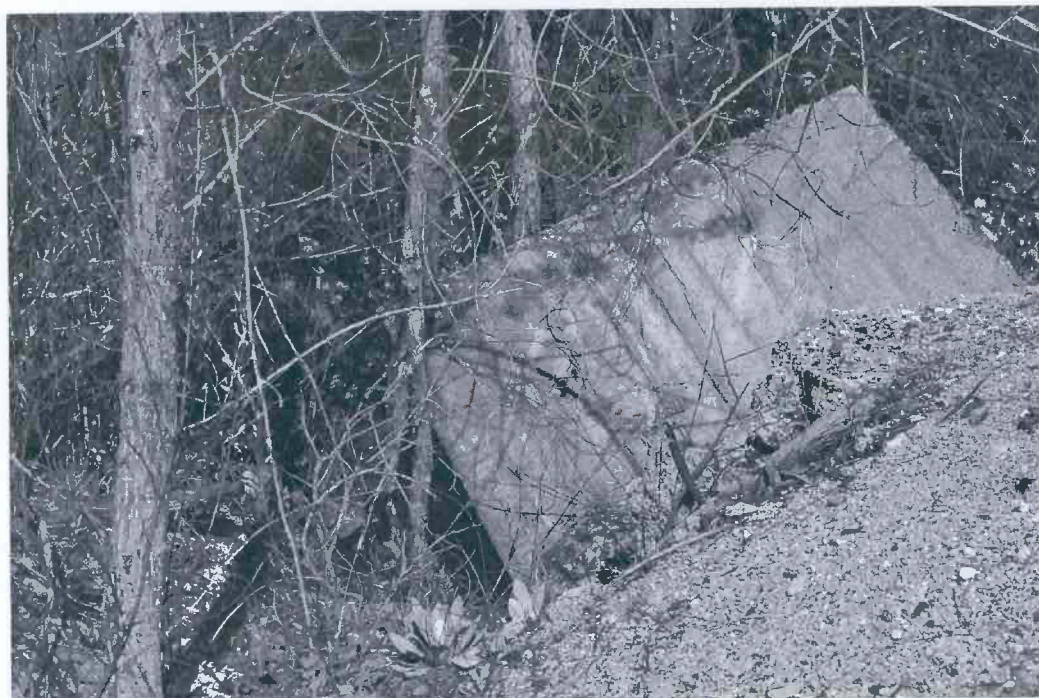
Figure 14. A 6.5-ft concrete cube used to seal a shaft on Grace Walker lease, 29N-23E-21(41).

when moderate-sized collapse features were associated with some shafts. A 6.5-ft concrete cube was fabricated at the site (Fig. 14). After the concrete was completely hardened—generally being allowed to set for at least a week—light charges of dynamite were used to blow out support for the cube on the side nearest the shaft, thereby allowing it to topple into the shaft opening. This method of sealing a caved shaft was found to be highly satisfactory, even though no control could be exerted over the final position of the cube. Some of the existing caved shafts in the Picher Field could be sealed in this manner.

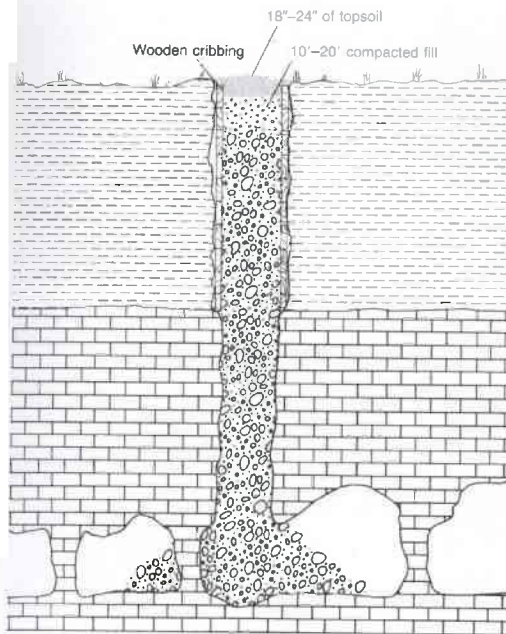
Figure 15. Schematic cross section of open mine shaft, illustrating one way to seal or close the opening in early stage of shaft failure.

An open mine shaft like the one depicted in Figure 10A may be filled in the manner shown in Figure 15. Material dumped into a mine shaft will generally form a conical pile on the floor of the underground mine working below the shaft. The size of the pile will depend on the type of material used, the height of the pile (vertical distance between the floor and ceiling), and the proximity to nearby support pillars. The angle of repose, or angle at which loose material will come to rest on a pile, varies with the frictional properties of the material and increases slightly as the size and angularity of the fragments increase.

The relative applicability of locally available materials for filling the voids is affected by water that fills all the mines in the Picher Field. If chat (coarse- to fine-sand-sized material) were dumped into a mine shaft, it would have a tendency to move laterally along the floor of the mine workings, assuring low angles of repose. This condition would probably require that large quantities of chat be used to fill some of the underground mine openings. Furthermore, saturated chat in an unconfined state, such as in an underground mine working, may move laterally under the weight of the fill within the shaft, causing recurring settlement problems. For these reasons, chat is not recommended as an initial fill material in the unconfined portion of the mine. Waste rock from the

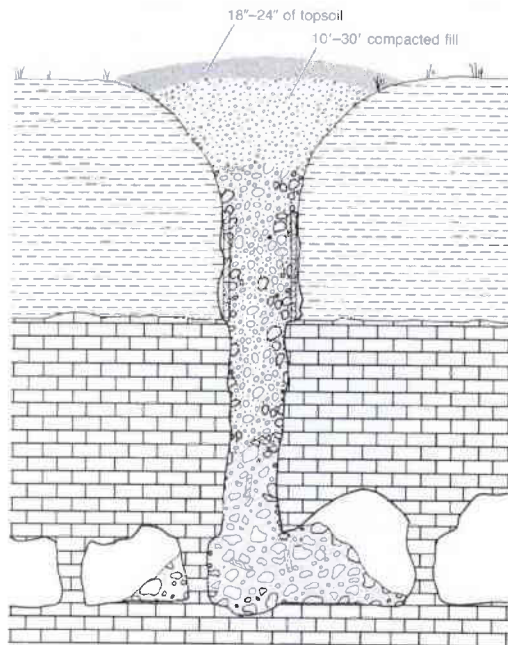
Figure 16. Schematic cross section of shaft site illustrating one way to seal or close the site in early stage of shaft failure.

An example of one way to fill a site that is in an early stage of shaft failure is illustrated in Figure 16. The shaft-filling technique is almost the same as that for an open shaft. Debris derived from material that caved into the shaft is shown occupying the lower part of the mine shaft. Most commonly, the underground opening is sufficiently large that the debris pile resulting from surface collapse is not high enough to extend upward into the shaft. The debris is usually composed of poorly consolidated, saturated shale and sandstone fragments and will offer little support to any fill material dumped on top of it. Therefore, initial volume estimates could assume that the debris plays no role in a shaft-filling program. After several shaft-collapse sites are filled, volume estimates could be modified to reflect actual site conditions.

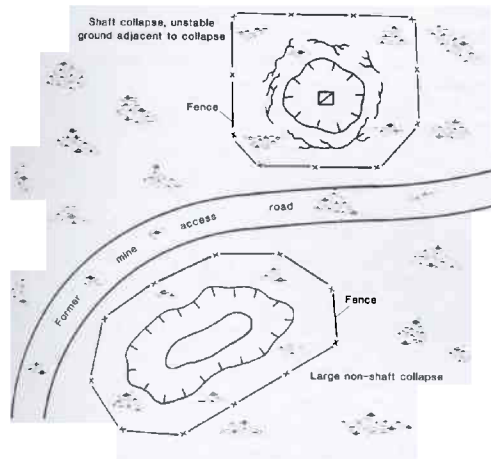
Figure 17. Fencing is a suggested safeguard for shaft collapses with adjacent unstable ground, as well as for very large collapse features. Periodic surveillance and maintenance of fences would be required.

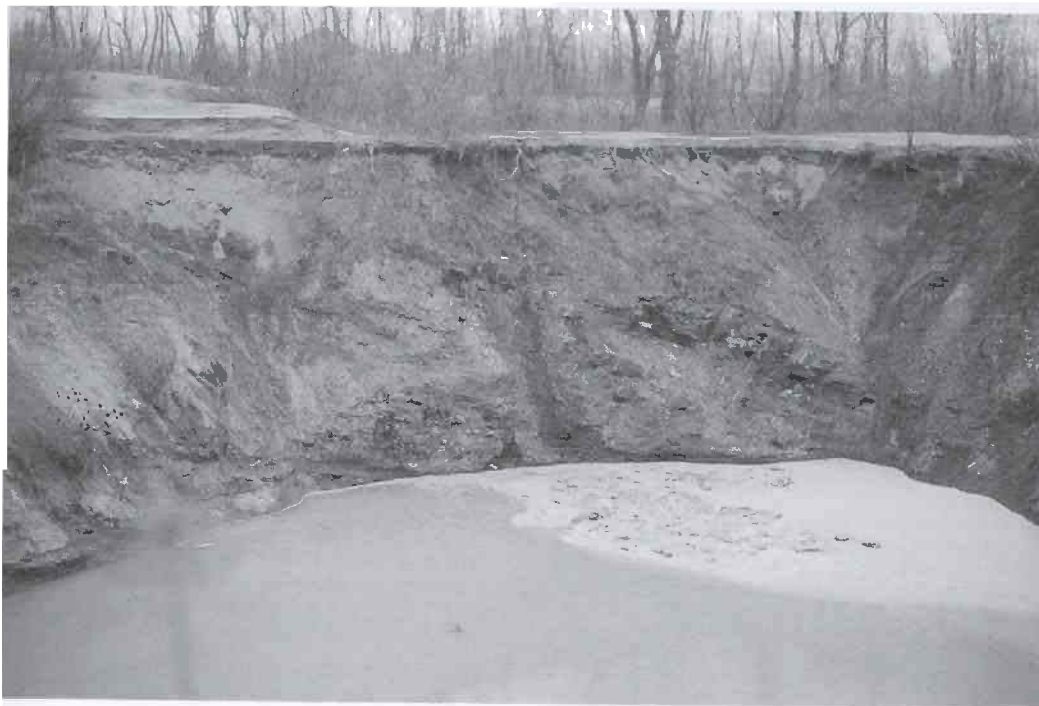
Figure 18. A 240- × 160-ft elliptical non-shaft collapse, Crystal Mine, 29N-23E-19(1504); water level is 45 ft from surface.

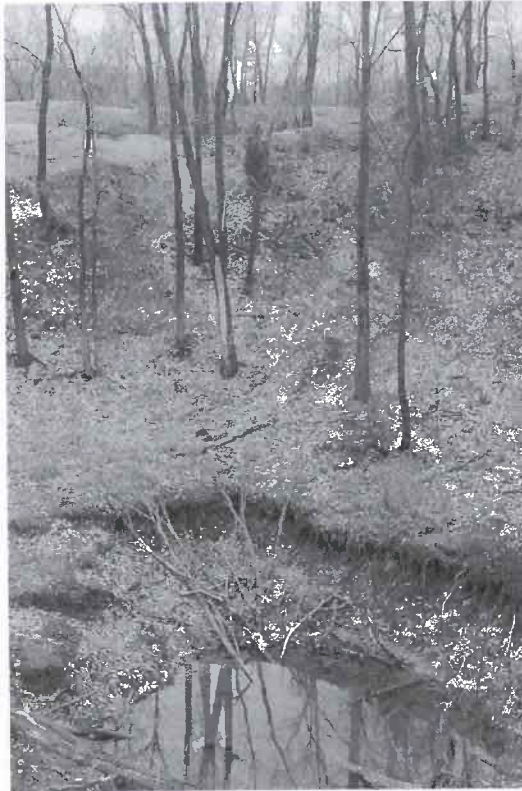
Figure 19. Trees growing in the bottom and sides of a 160-ft circular non-shaft collapse, Crystal Mine, 29N-23E-19(1507).

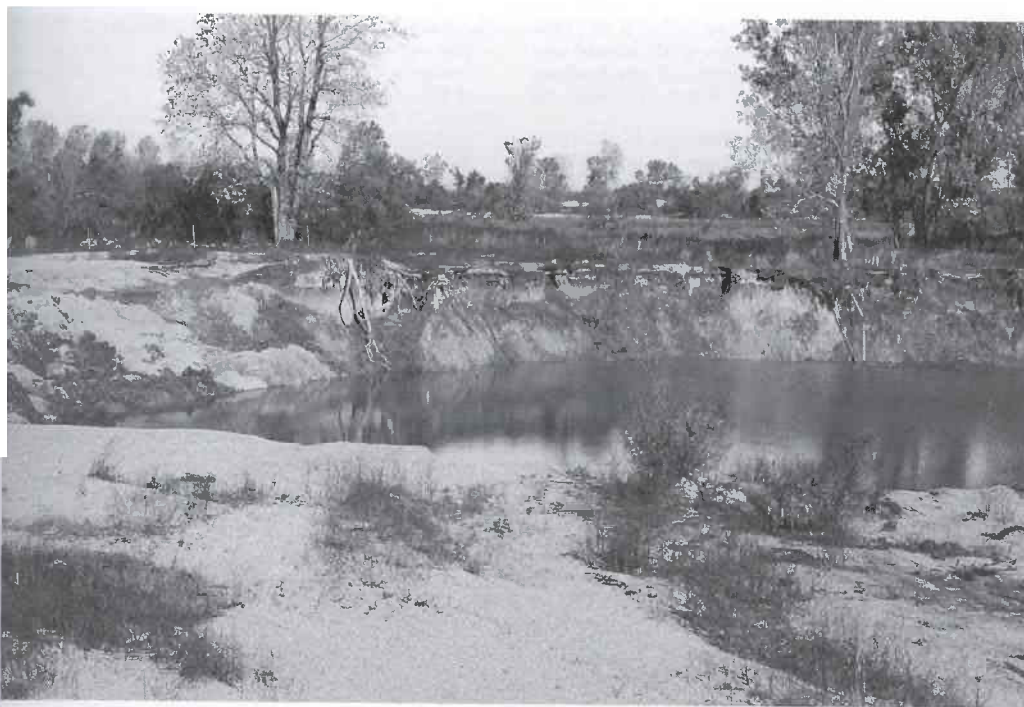
Figure 20. A 220-ft circular collapse, Goodeagle Mine, 29N-22E-25(5). The collapse increased four times in size in about six months.
