OKLAHOMA GEOLOGY NOTES

A closer look at the 2015 rockfall

What caused it?
Could it happen
again?

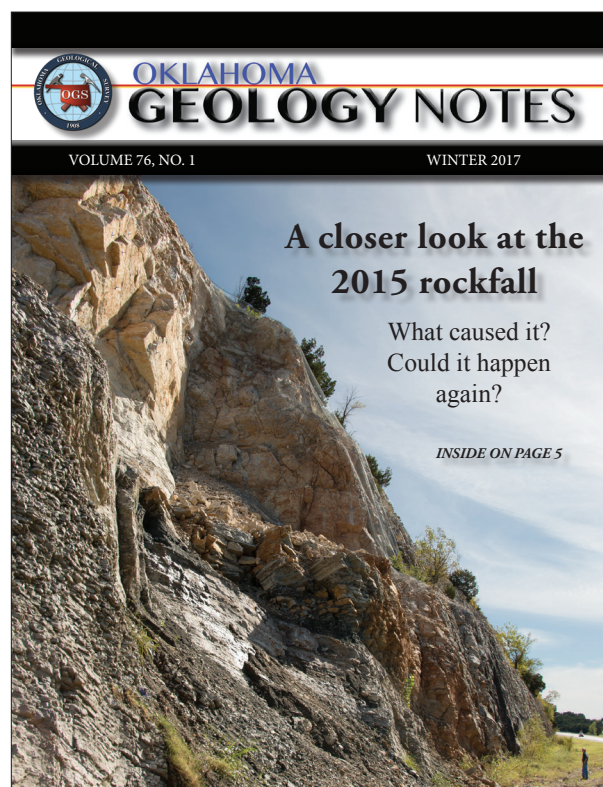
Cover: Outcrop at the site of the 2015 rockfall. Photo was taken in October 2016. (Photo by Ted Satterfield).

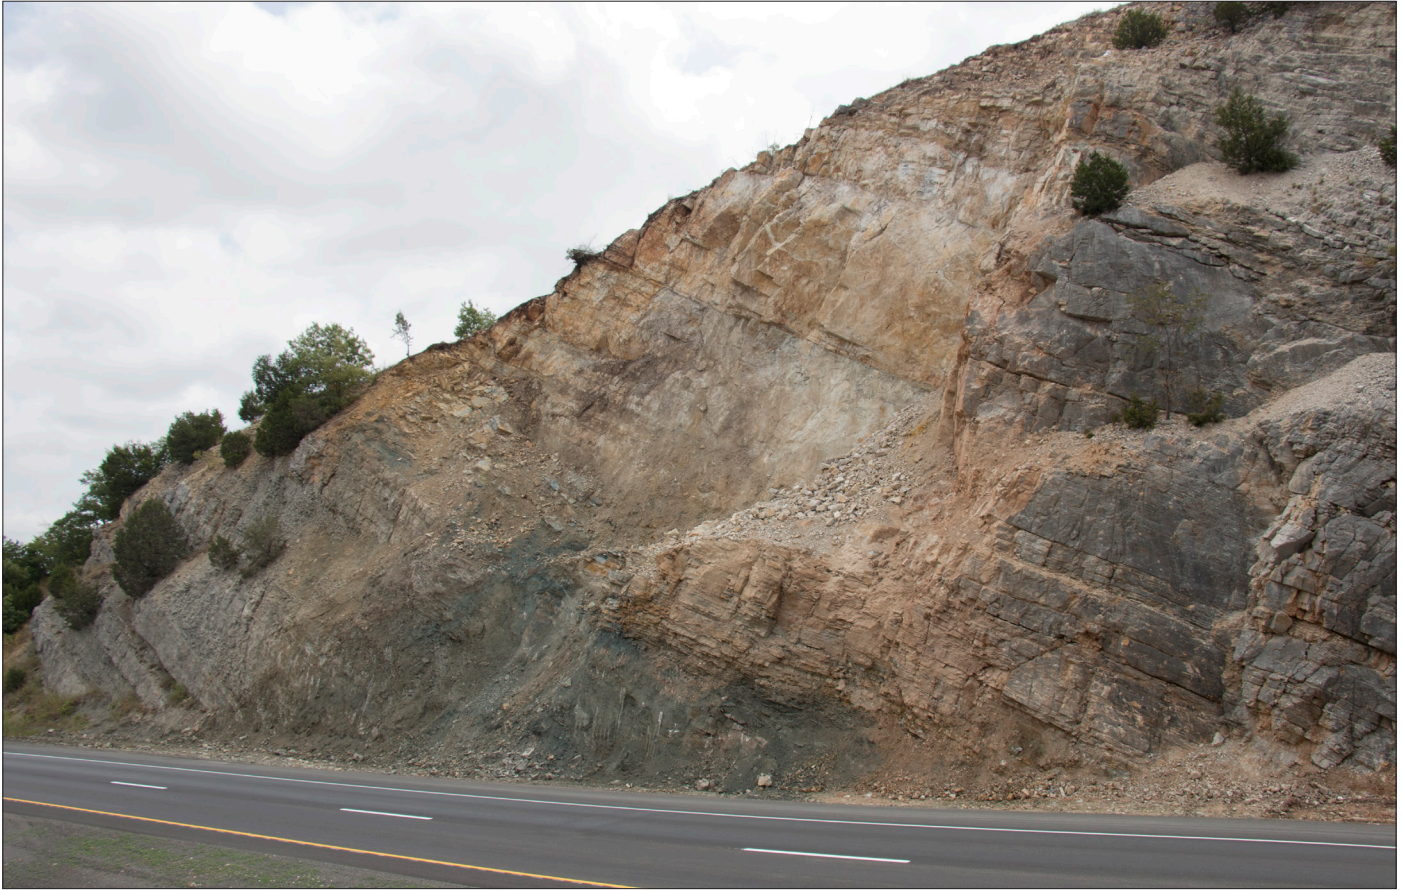
Figure 4. (Top) This photo shows the full outcrop of the area where the rockfall occurred after the debris was cleaned up. The beds along the hill at mile marker 50 strike in a northwesterly direction and dip normally 25-30 degrees to the southwest.

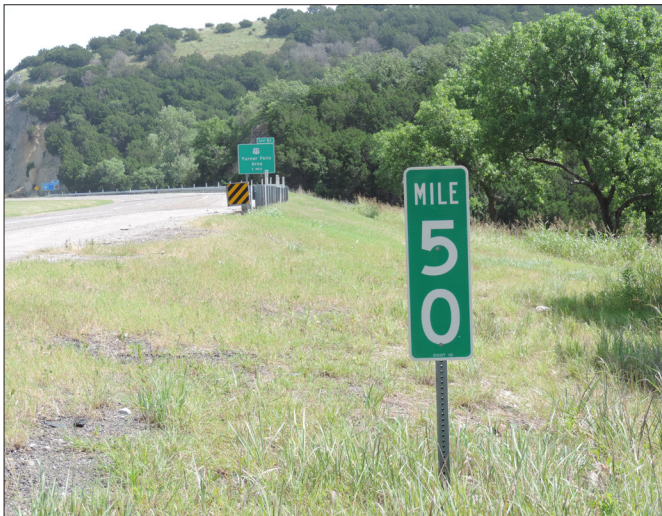
Figure 5. (Above) The rockfall took place close to this spot at mile marker 50 along northbound I-35.

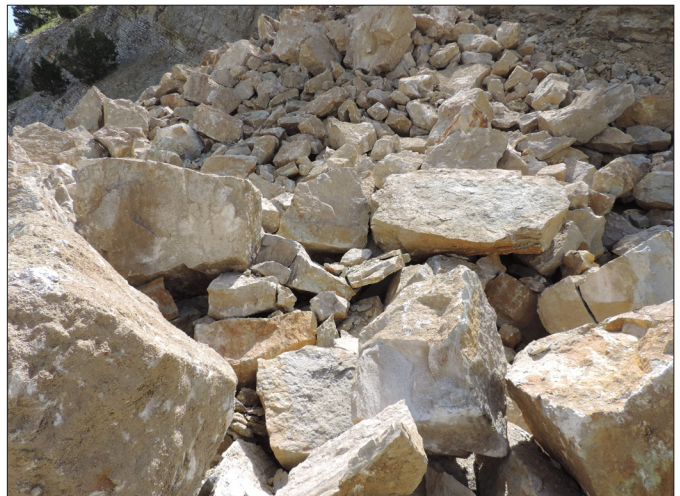
Figure 7. (Below right) This photo shows the variety of rock sizes at the site of the rockfall.

Light-gray limestone weathering to tan composed the majority of the larger blocks in the debris pile – some pieces were seven-to-ten ft in length, six-ft wide, and five-ft tall (Figures 7, 8, and 9). These were interpreted to have come from the Pooleville Member near the top of the hill. The smaller rocks included gray limestone and pieces of gray wackestone and calcareous mudstone with some dark-gray to green argillaceous shale mixed in. Many of the thinner bedded fine-grained rocks, less than a foot in girth, were found lying below and between the larger limestone blocks in the pile (Figure 7). Most of the smaller limestone and fine-grained rocks were interpreted to have come from the Mountain Lake Member.

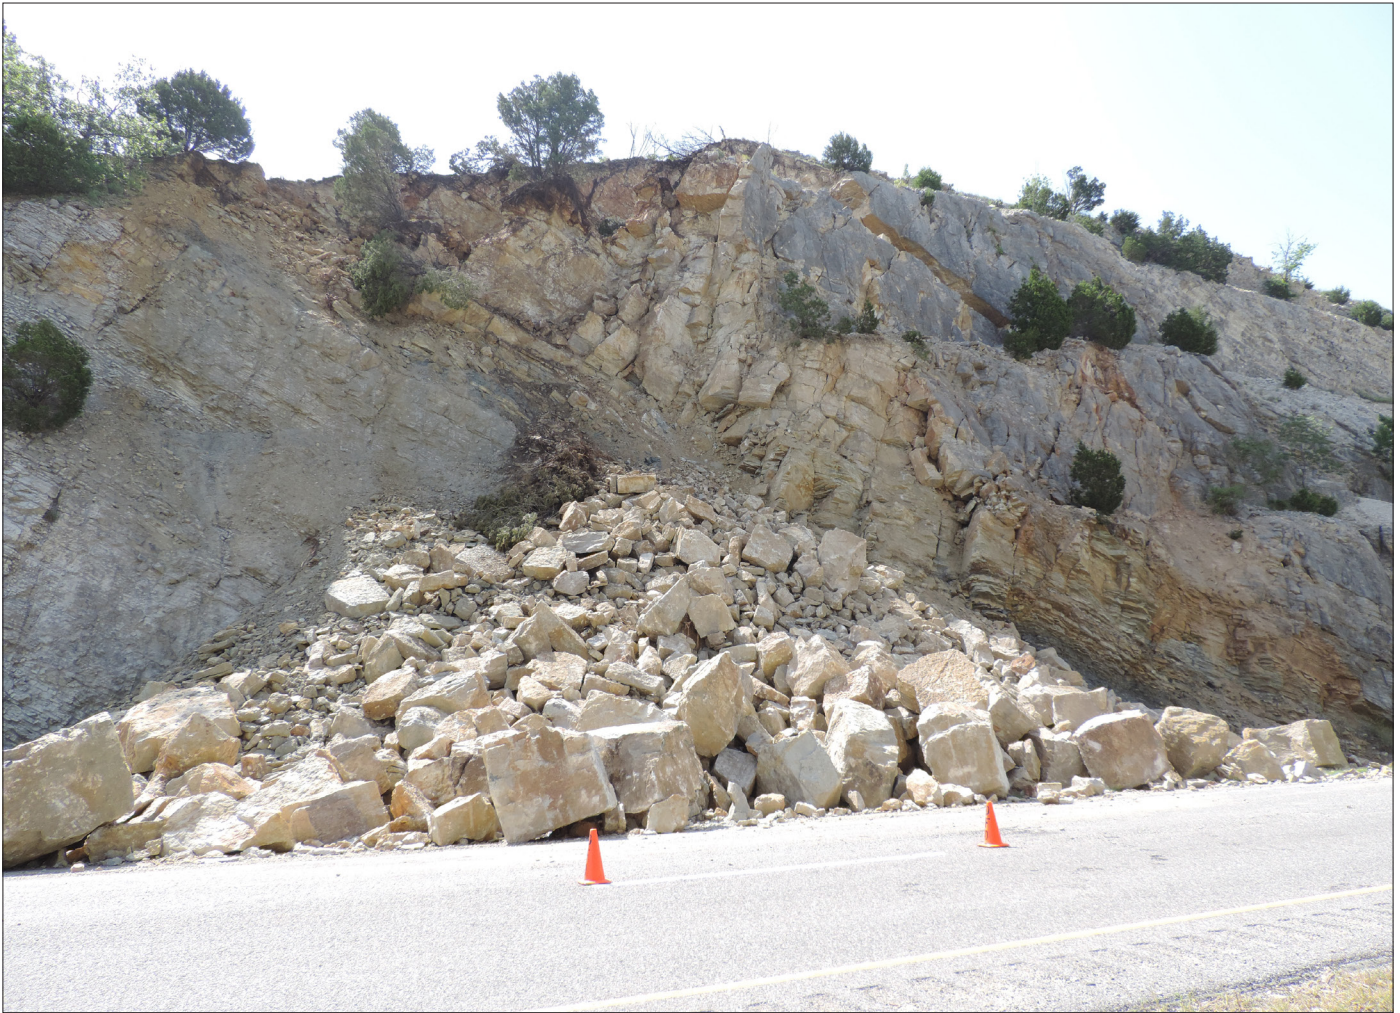
Figure 8. This photo shows the outcrop before the debris was cleaned up.

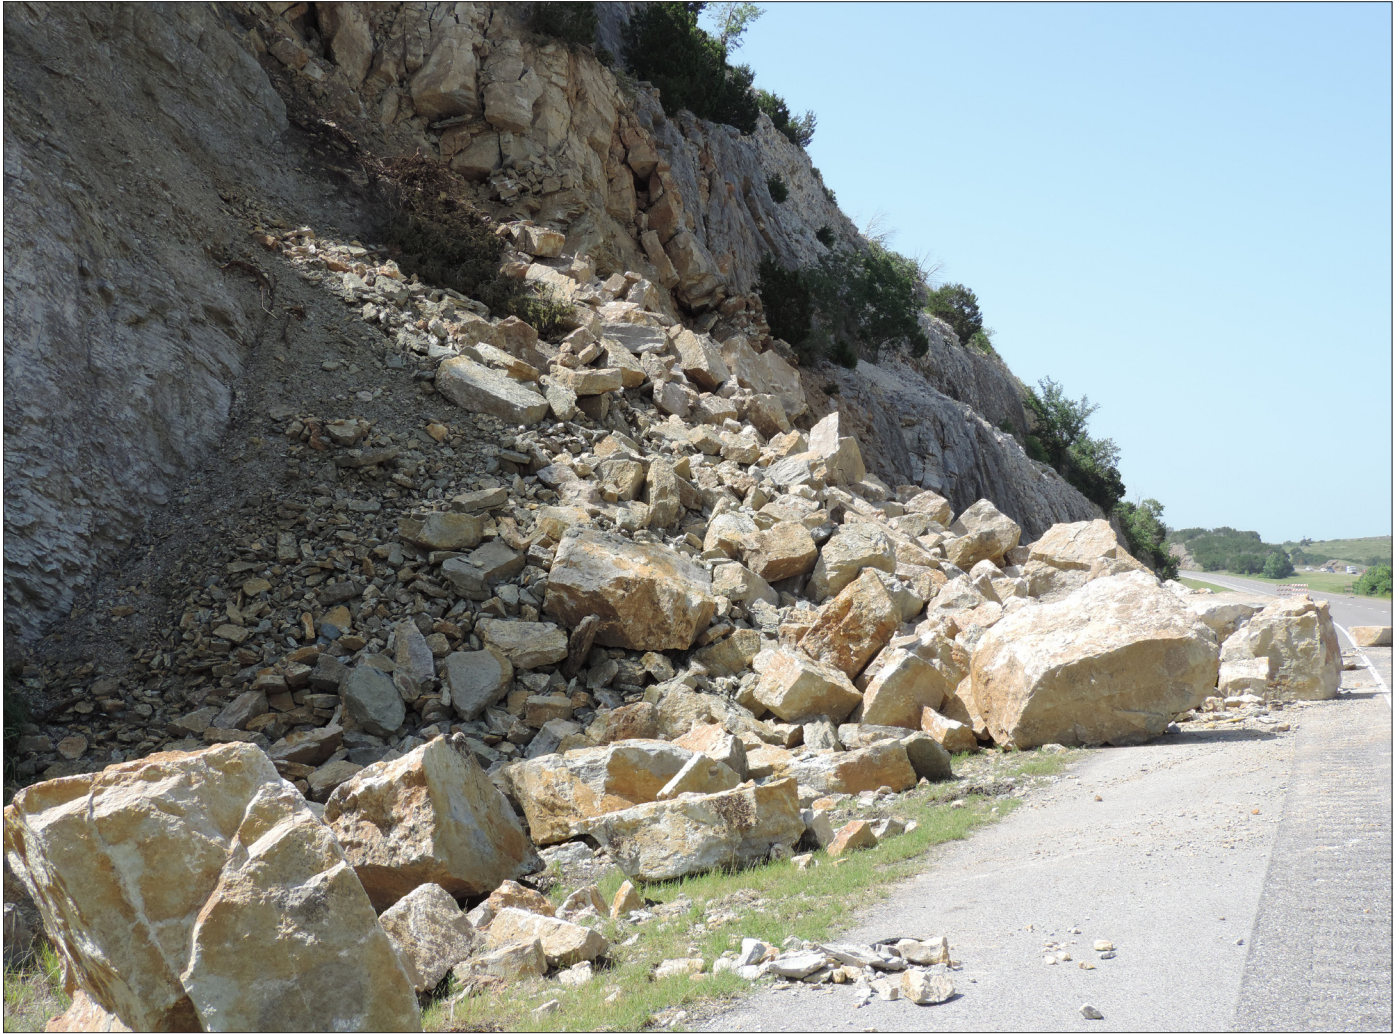
Images from Google Street View show this particular site in early 2015. A small drainage feature can be seen to have already deposited rocks at the bottom of the slope in a typical alluvial fan pattern. This feature was greatly accentuated by historic rainfall later in the year (Table 1). It was only a matter of time before erosion caused naturally fractured rocks near the top of

Figure 9: A fan of rock debris lays scattered along the side of the road, with large rocks falling onto the road.

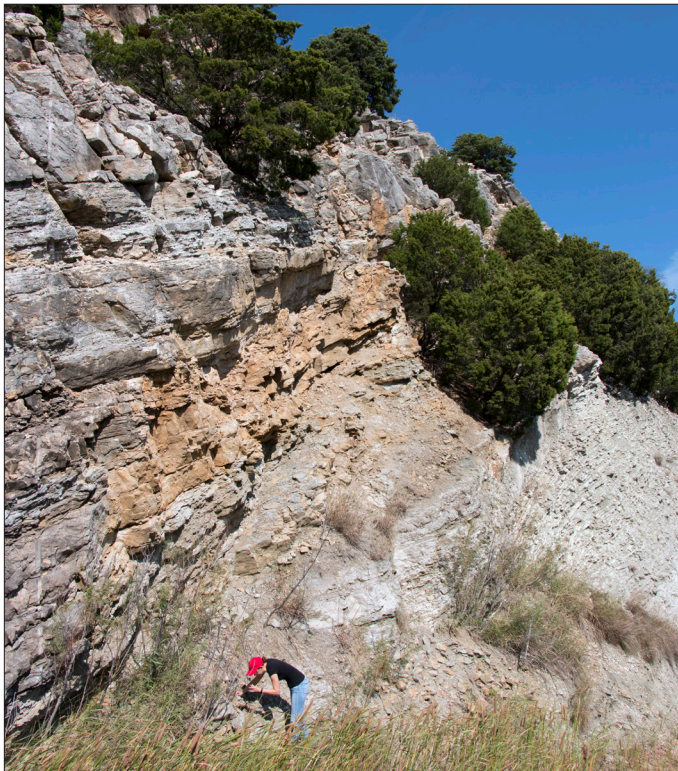
Figure 11. The west side of I-35 (directly opposite of the rockfall) shows trees growing out of natural fractures in the rock face.

It should be noted that the hillside morphology associated with this rockfall can be seen in mirror image in the roadcut on the opposite side of the interstate (Figure 11). There, the same geology and slope

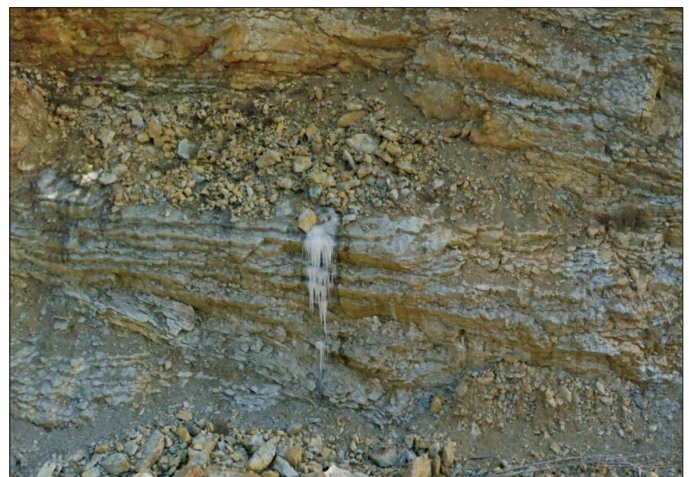
Figure 12. Pre-rockfall images from Google Street View (2015) show ice forming within cracks in the outcrop just south of the site of the rockfall. This is a clear indication of water flow through the rocks

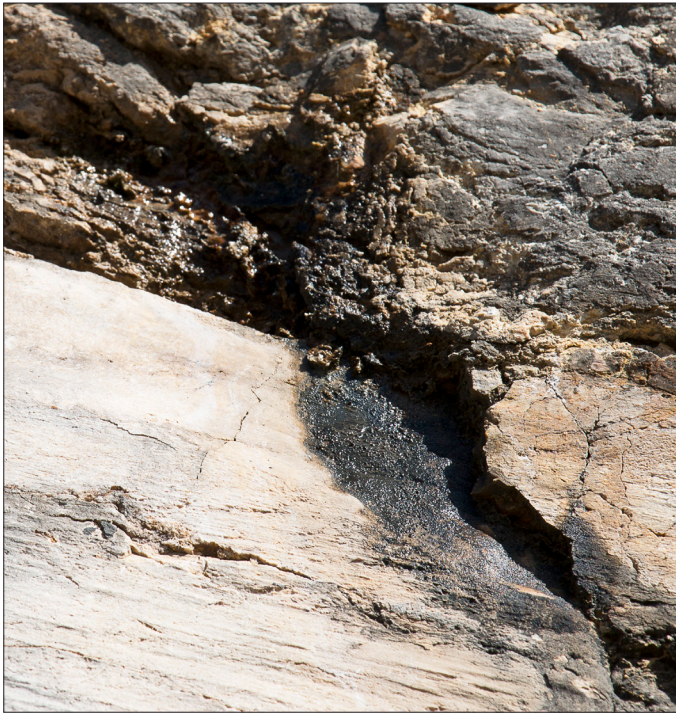
Figure 13. Water is seen flowing out of cracks in the outcrop at the location of the rockfall in October 2016.

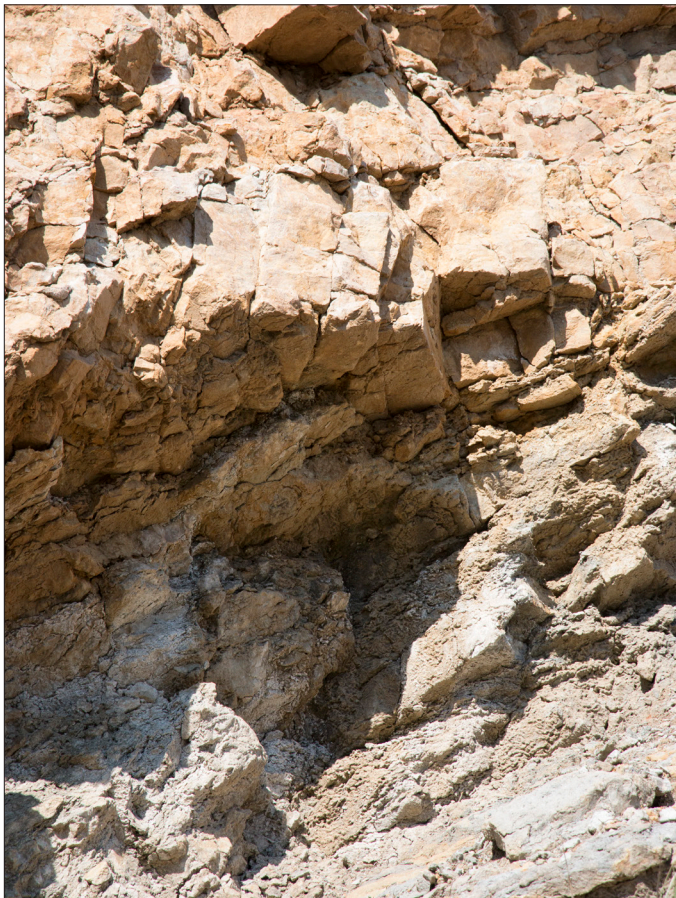
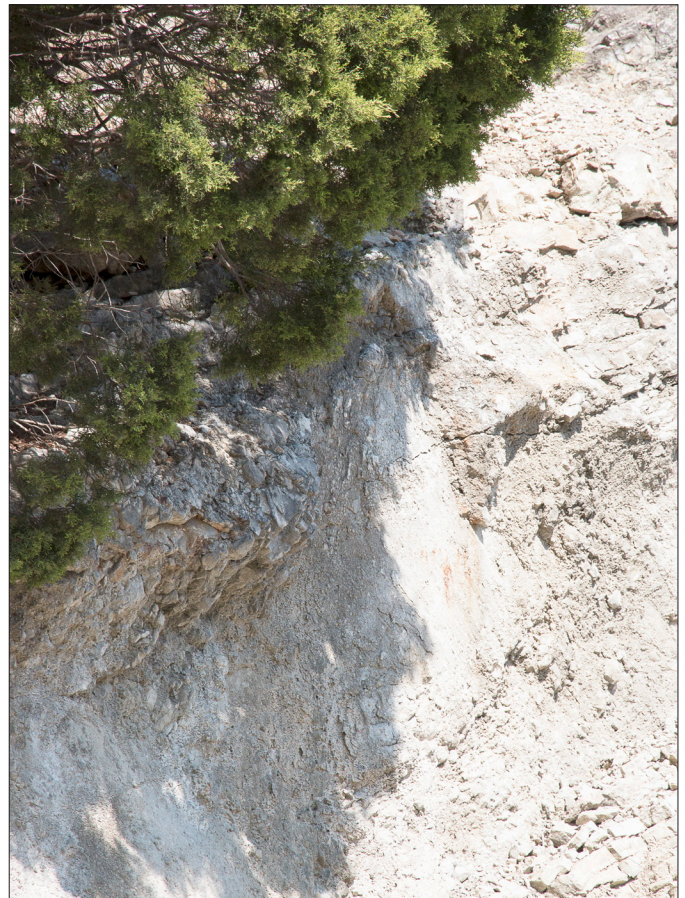
Figure 14. (Left) On the opposite side of I-35 across from the rockfall, blocky more consolidated layers can be seen protruding as ledges over finer-grained material below. The protruding blocks are poised to fall at any time. **Figure 15.** (Right) Also on the opposite side from the rockfall, vegetation can be seen growing along fractures of the thicker-bedded layers above the finer-grained material. Roots expand the fractures making the rocks more unstable.

conditions occur along the southbound lanes. Small drainage features and fractured upper blocks are present, and the finer-grained cliff face of the lower slope is slowly eroding into the hill (Figures 14 and 15). If no efforts are made to mitigate this situation, it is possible that a similar rockfall could occur on that side of I-35.

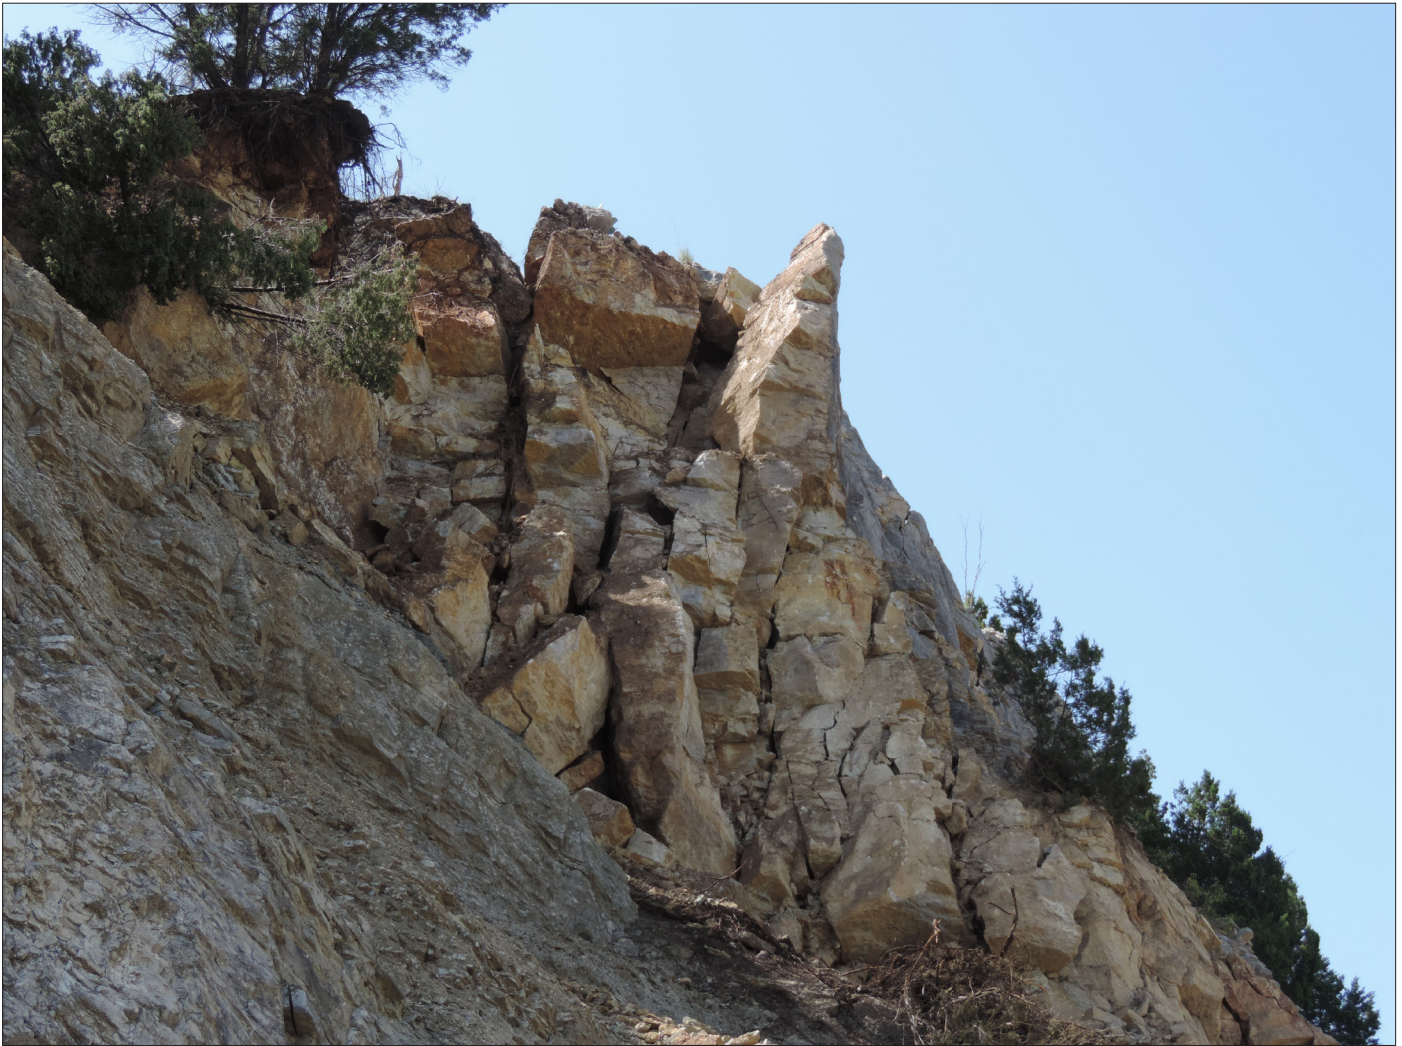
Figure 16. Rocks at the top of the rockfall site hang precariously after the rockfall but before the big blast.

Early assessments determined that not all of the potentially dangerous rocks fell in the original incident. Some blocks were left hanging near the top of the hill (Figure 16), and for several days debris could be seen randomly falling down the slope. A decision was made to remove this loose material by force.

selectively placed approximately 400 lbs of explosives for use in bringing down the unstable rocks. Near 7:00 pm on July 8th, all lanes of I-35 were closed north and south of the rockfall. Only the engineering crew, ODOT/OGS officials, and some media were allowed within one half mile of the blast site. An eerie silence fell across the surrounding hills as noise from interstate traffic was temporarily suspended for the first time in perhaps decades. Birds could be heard chirping and conversations were possible with only whispers. A countdown commenced and then the warning “Fire in the hole!” In the distance, a silent eruption of rock and dust pushed outward from the hillside followed shortly after by the trailing sound of a strong, yet muffled, base thump. A sound like rain was heard next as thousands of pieces of rock cascaded down the slope and fell from the sky amid a huge cloud of dust. Moments later the eerie silence returned.
