OKLAHOMA
GEOLOGICAL
SURVEY

CIRCULAR 88

Stability Problems Associated with Abandoned Underground Mines in the Picher Field Northeastern Oklahoma

1986

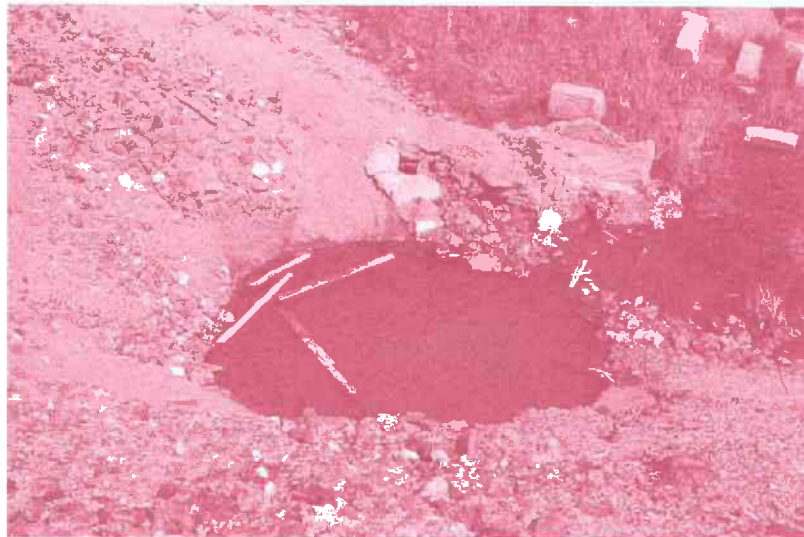
Title Page Illustration

A 20-ft-diameter circular collapse, Howe Mine, 29N-23E-17.

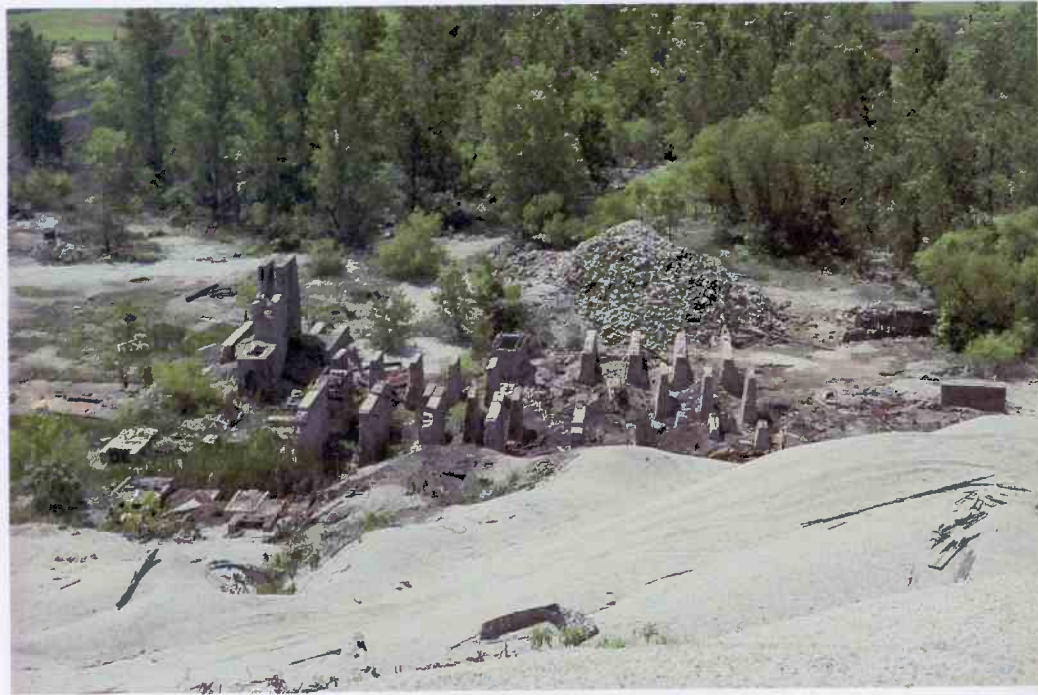
Significant quantities of mill-waste material were generated by milling of the lead-zinc ores (Figs. 8,9). Stroup and Stroud (1967) reported that approximately 5,000 surface acres were affected by mine- and mill-waste materials. However, a recent tabulation of mine- and mill-waste materials suggests that approximately 2,900 acres in Oklahoma were overlain by mine and/or mill by-products. The discarded mill-waste material, chiefly composed of chert fragments 0.75 in. or less

Figure 8. Foundation for former mill at St. Louis No. 4 Mine (29N-23E-24). Boulder pile is adjacent to mill, and chat pile is in foreground.

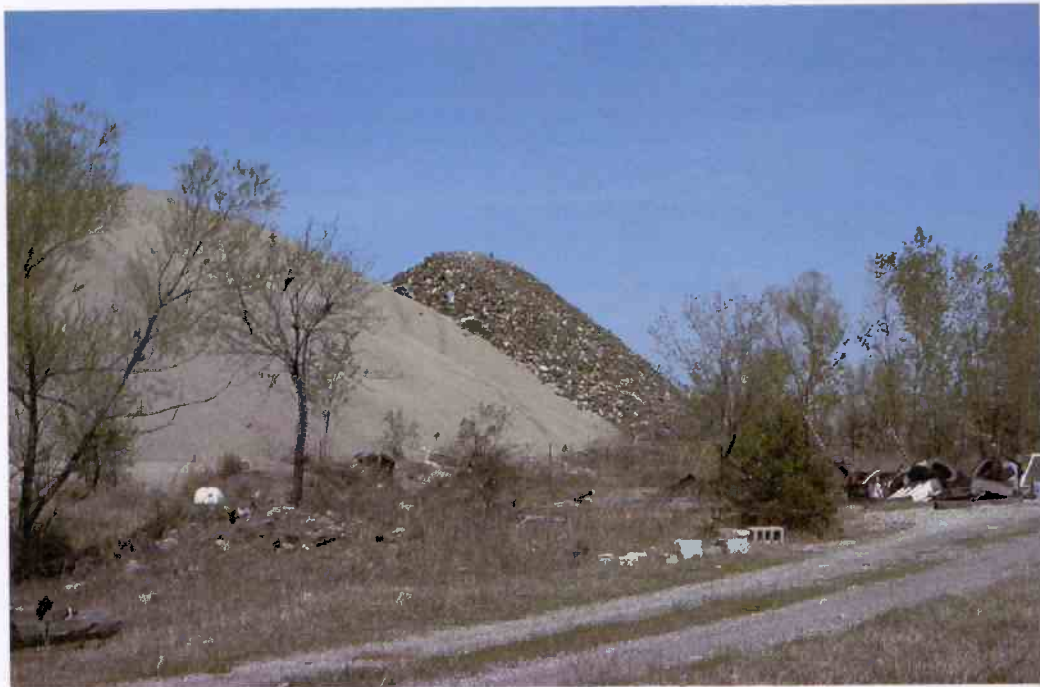
Figure 9. Large chat pile (*left*) and boulder (*right*) at Howe Mine (29N-23E-17).

large boulder piles found adjacent to most mine shafts would be better suited for the initial fill.
