OKLAHOMA GEOLOGY NOTES

A closer look at the 2015 rockfall

What caused it?
Could it happen
again?

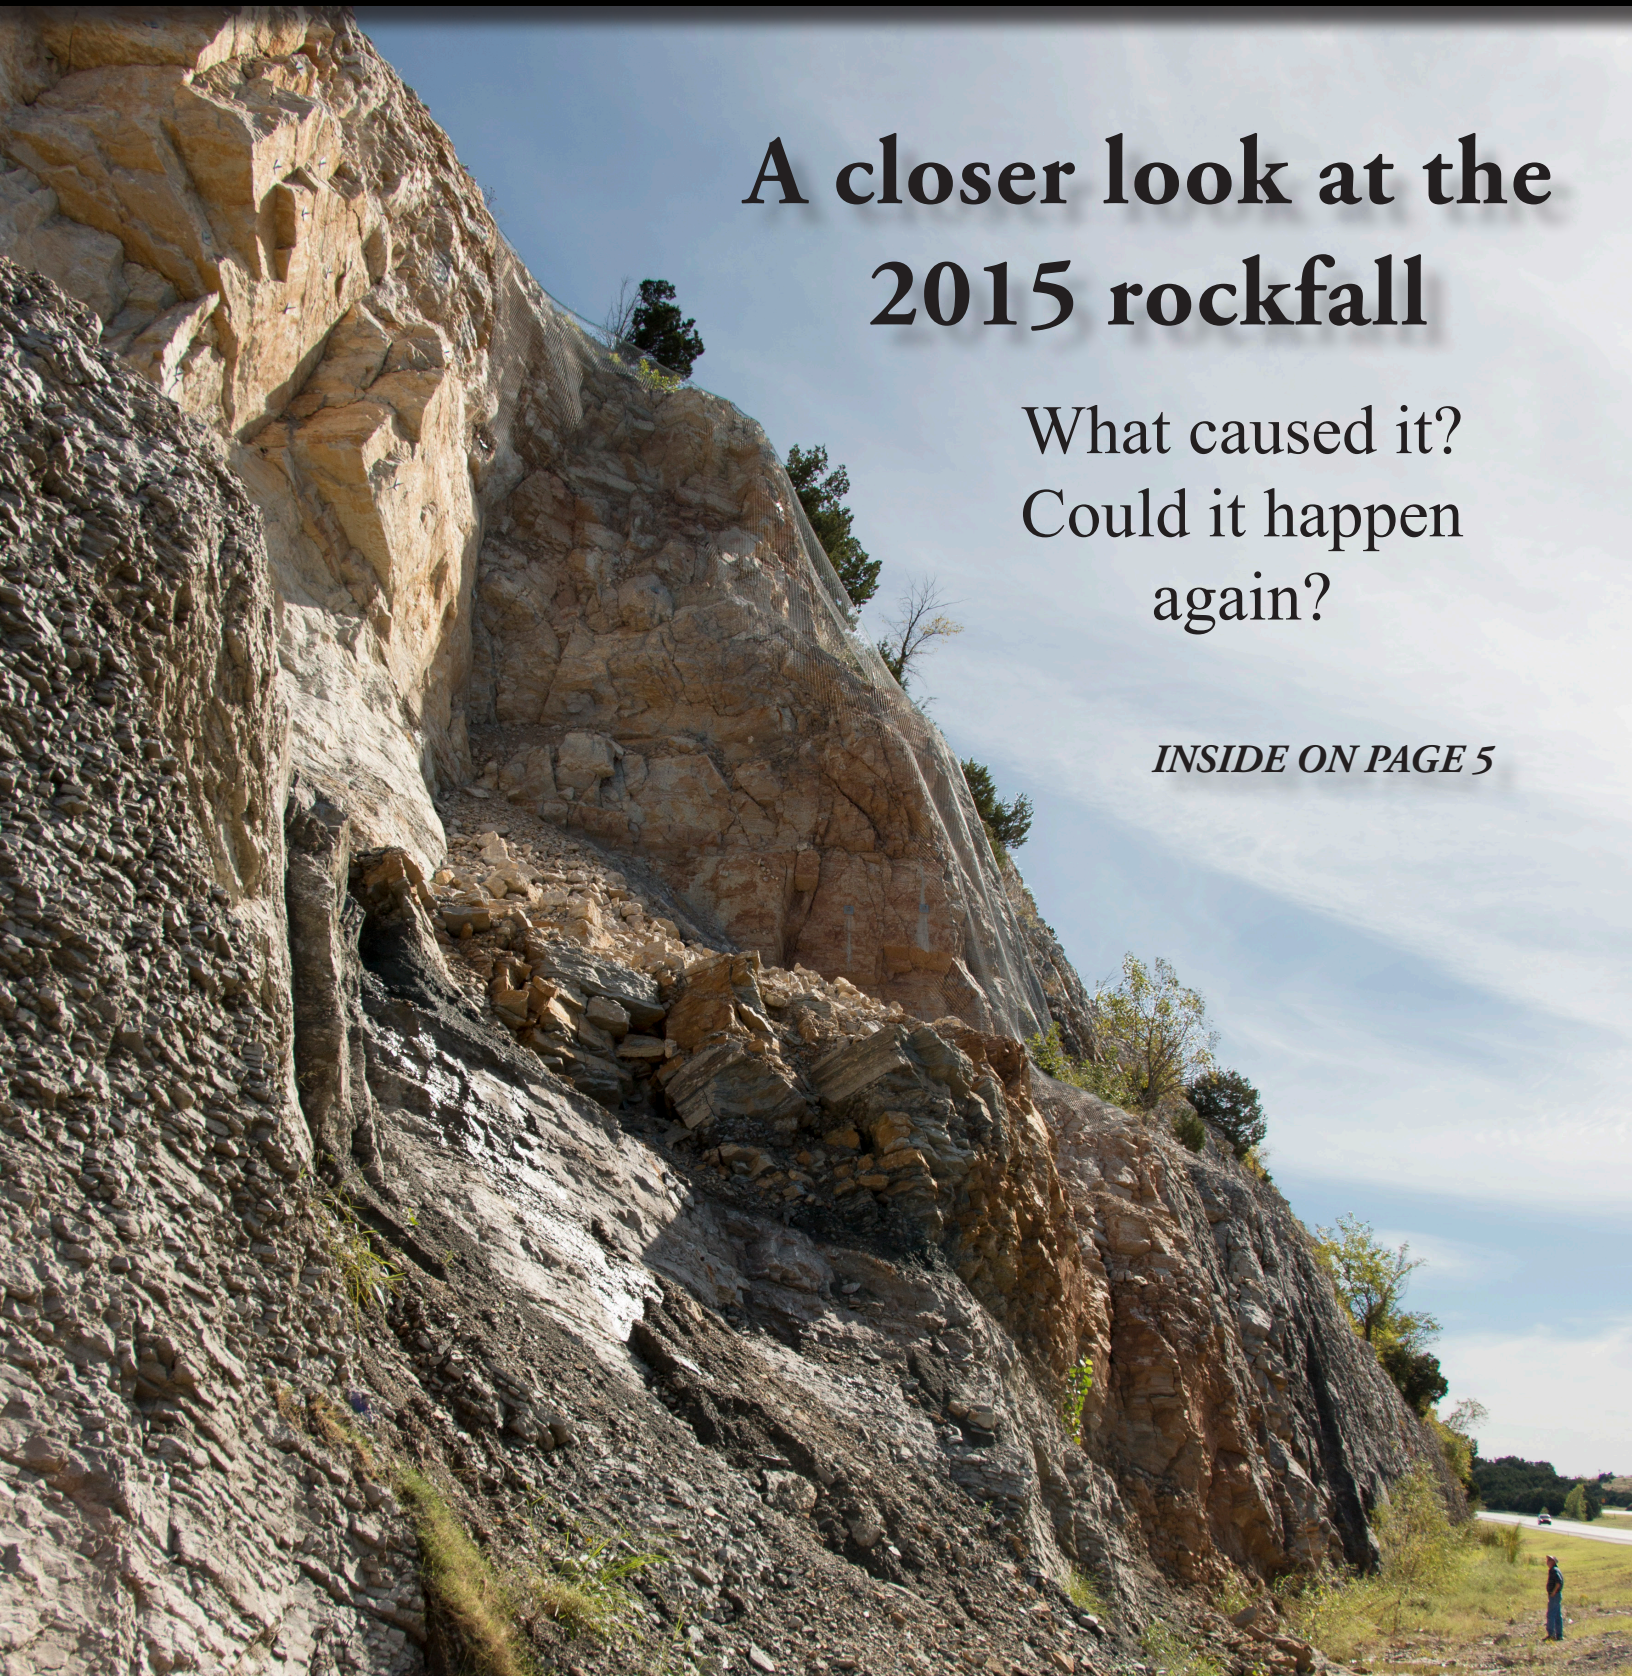
Cover: Outcrop at the site of the 2015 rockfall. Photo was taken in October 2016. (Photo by Ted Satterfield).

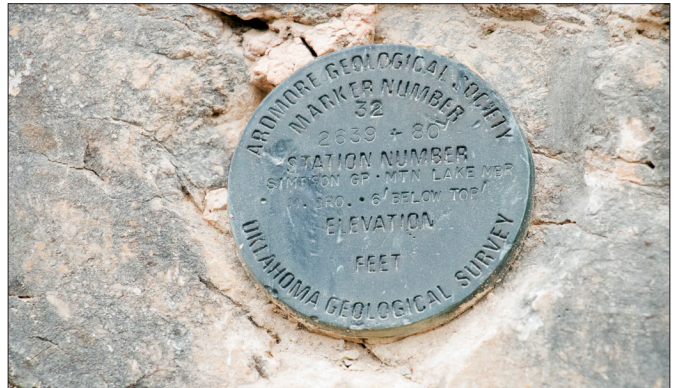
Figure 4. (Top) This photo shows the full outcrop of the area where the rockfall occurred after the debris was cleaned up. The beds along the hill at mile marker 50 strike in a northwesterly direction and dip normally 25-30 degrees to the southwest.

Figure 5. (Above) The rockfall took place close to this spot at mile marker 50 along northbound I-35.

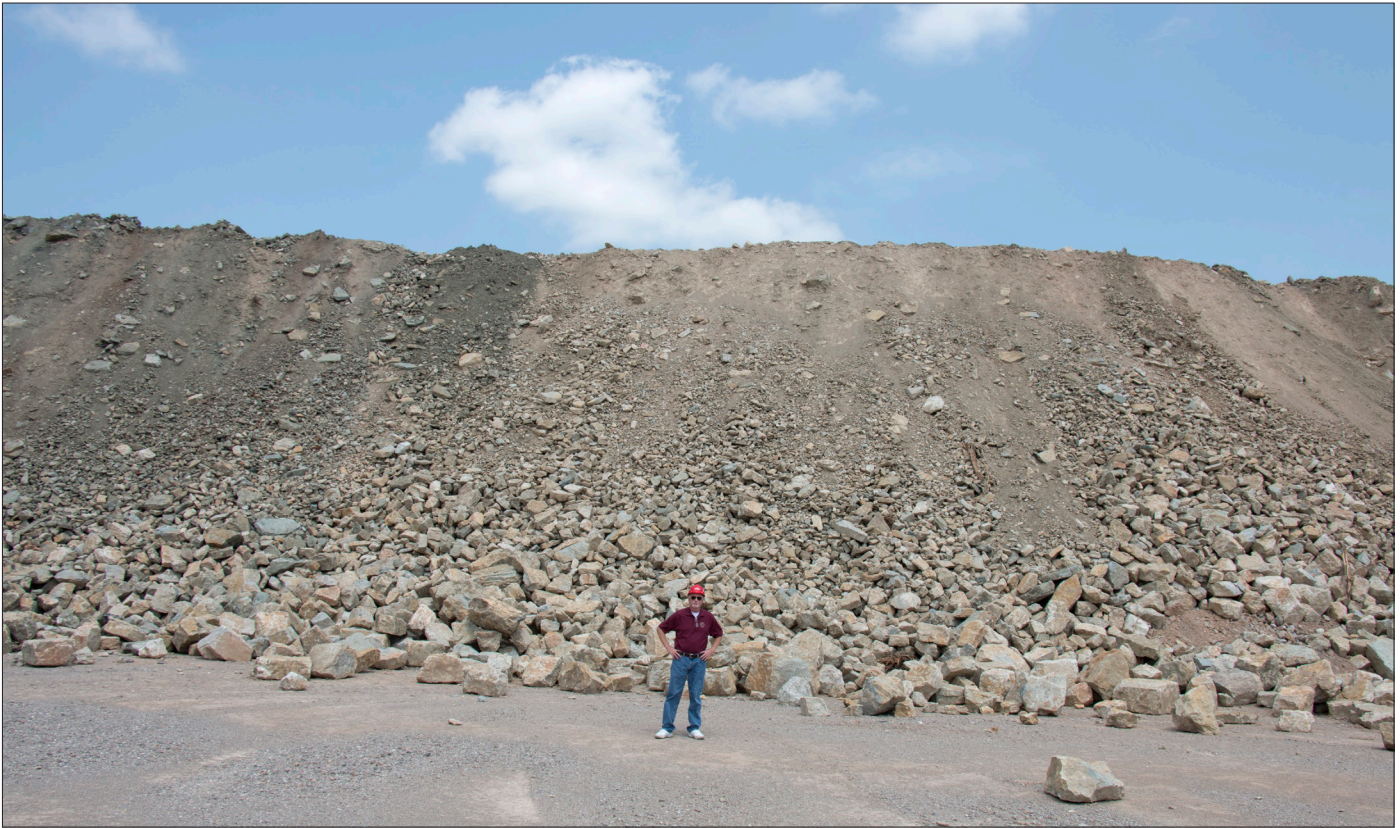
Figure 19. The final resting place of the debris from the rockfall is the Dolese Quarry west of Davis, Oklahoma.

The debris from the rockfall was transported to the Dolese Quarry west of Davis, Oklahoma. Dump trucks worked around the clock for 2 weeks to relocate the mass to its new home. Quarry officials reported that 12,820 tons of rock was delivered to their facility, although over 14,000 tons was estimated to have fallen, according to ODOT (2015d). It remains unclear what future uses the rock might have because there are strength and freeze tests that must be passed before any rock can be certified for use in certain commercial projects. So, now the rocks sit in the back of a large hole in the ground six mi. from their original depositional home (Figure 19). It is a nondescript final stop along a journey of distance and time for sediments that were laid down in an Oklahoma sea over 450 million years ago.
